# TECHNICAL BULLETIN

NO: TB-SC-FRA-004

<b>MODEL AFFECTED:</b>	ALL SPORTCRUISER SERIAL NUMBERS
<b>SUBJECT:</b>	FUEL-TANK FILLER CAP SWELLING
<b>ASSEMBLED AIRCRAFT AFFECTED:</b>	Due to the potential nature and frequency of this problem, this Technical Bulletin can affect all SportCruiser models using Automotive/MOGAS Type fuels.
<b>COMPLIANCE:</b>	Czech Aircraft Works recommends accomplishment of this bulletin IF the effects of fuel additives such as ethanol and other chemicals are affecting the normal operation of the Fuel-cap components or seals.

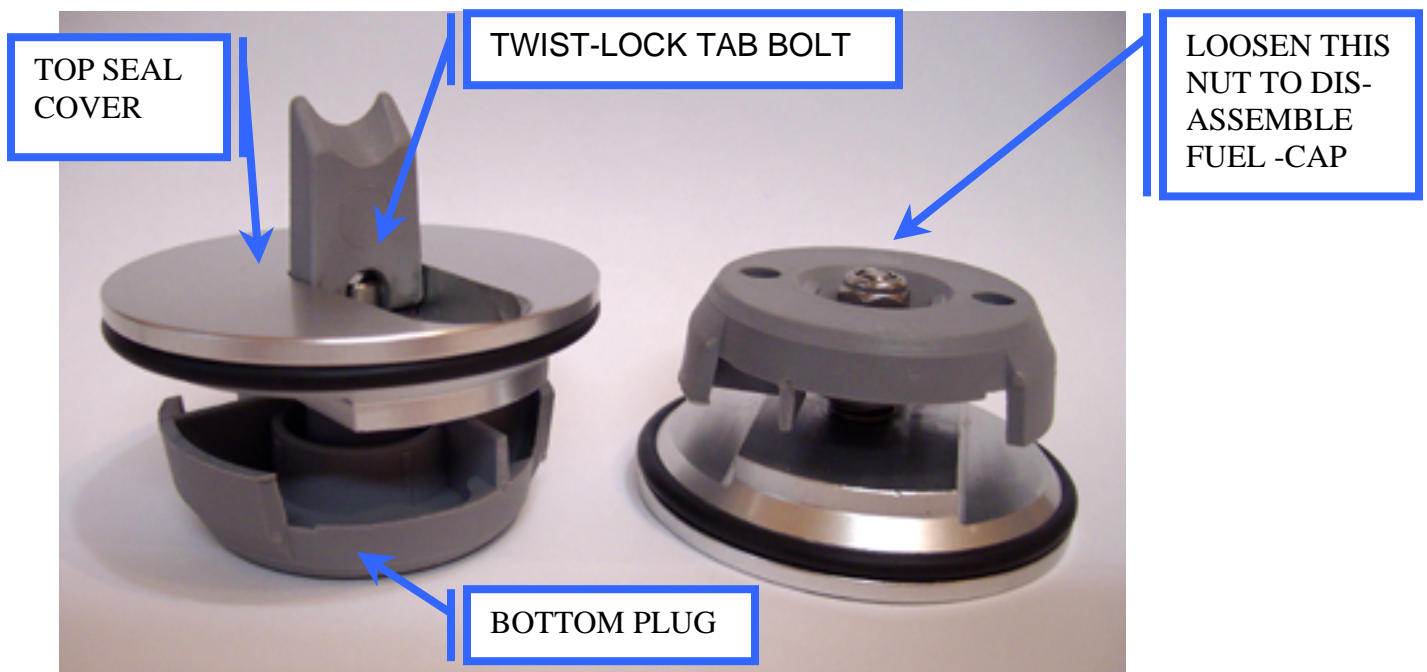
FIGURE 1.

1. Secure the aircraft indoors in a location where it is free of flying dust and debris.
2. Remove the fuel cap from one side and in its place stuff a very clean rag (free of dirt and other debris) in the fuel filler hole or be certain as to ensure nothing foreign can enter your fuel system while it is exposed with the Fuel-cap removed.
3. **TO DISASSEMBLE THE FUEL CAP:** Loosen the nut as shown in the diagram. The cap will come apart when the nut is removed. The cap is an assembly consisting of the twist-lock tab bolt, a spring, the grey circular bottom plug, and the metal top seal cover.
